**Bulletin ID:** UBCO-CS-00018  
**Date of Issue:** 02/08/2024  
**Bulletin type:** Service Bulletin  
**Audience:** UBCO DUTY Service Agents & Authorised Repairers

## DUTY – Post-production Rework

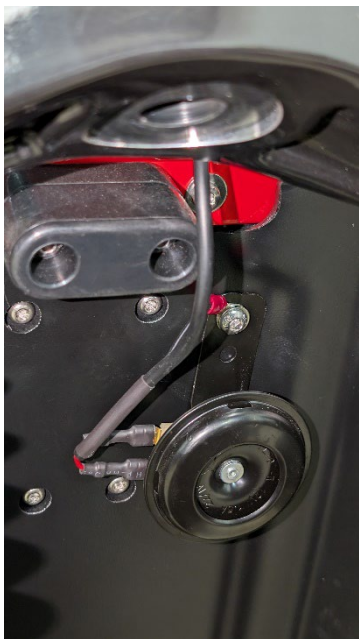
**Issue:** If the horn wire isn't retained it can get crushed between the steering stop and the triple clamp.

No P-Clip

**Action:** P-Clip to be installed on the wire.

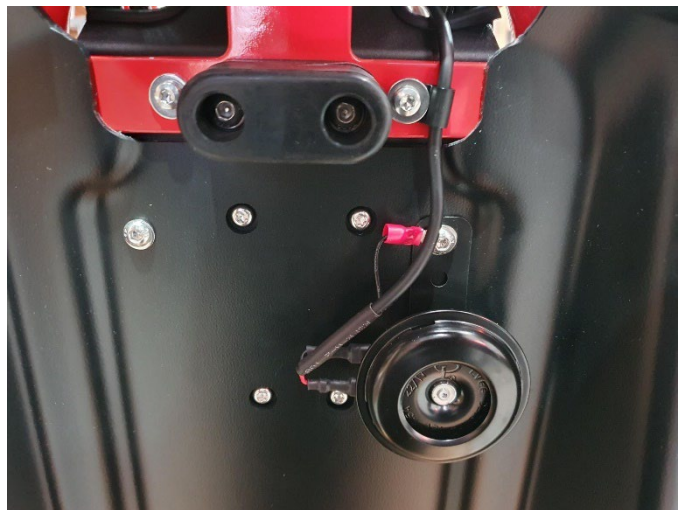
P-Clip Installed

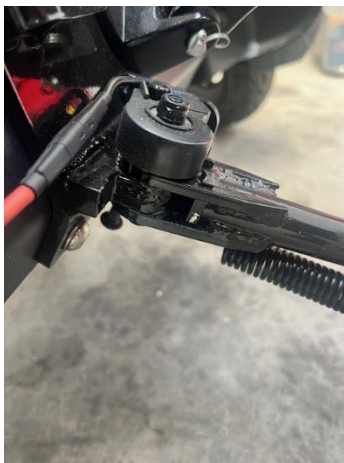
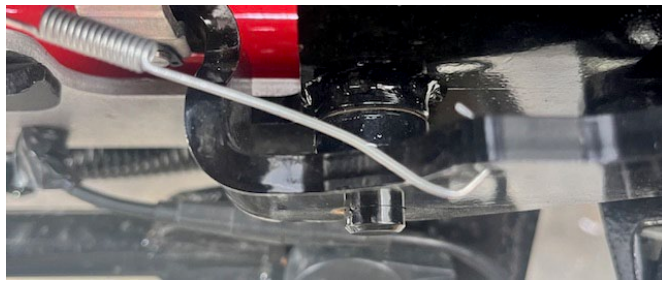
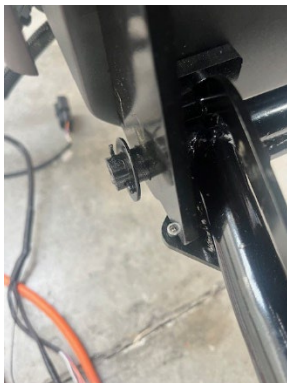
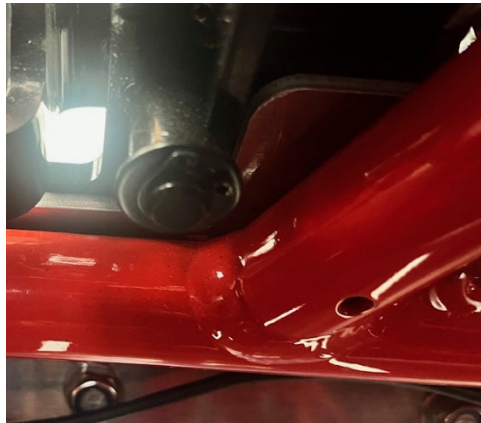
**Title:** lube side/centre stands and foot brake

**Issue:** During production, no lubrication was applied to the side/centre stands and the foot brake lever.

**Action:** Lube is to be applied to the side and centre stands and the foot brake lever. This can be carried out by moving the stand to one side and spraying in the pivot point, complete the same for the opposite side.

Use circlip pliers to remove the foot brake lever circlip to expose the shaft, spray lube and install the circlip.

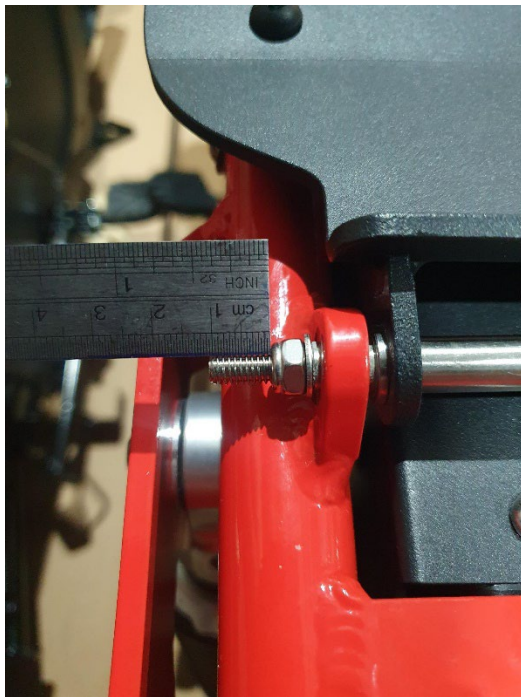
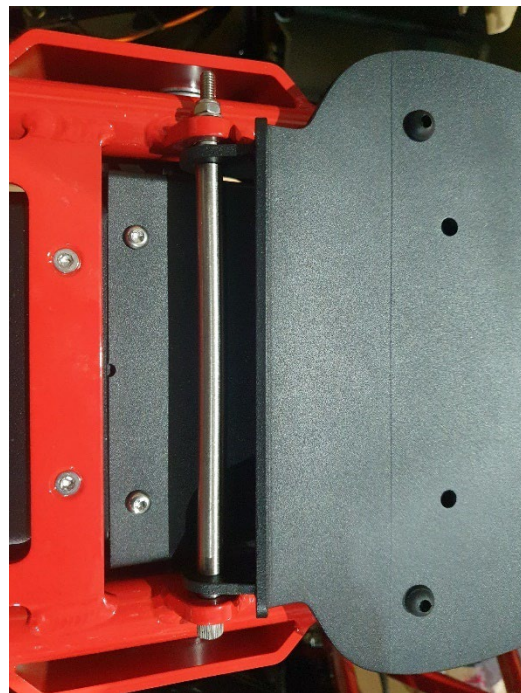
**Title:** Long bolt supplied with seats incorrect

**Issue:** Bolt supplied for with seat to long.

**Action:** Do not use the supplied single bolt, instead use bolts already installed on the seat pan. Return incorrect parts to UBCO AU.

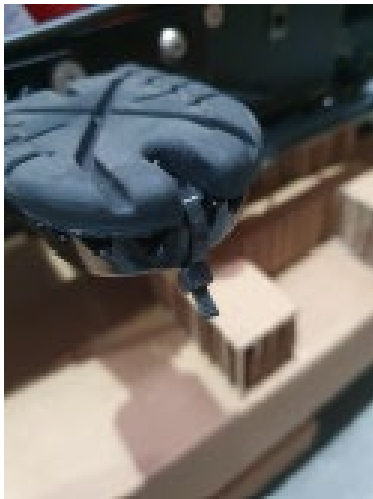
**Title:** Foot rubber cable ties

**Issue:** Foot rubber cable ties not cut and mounted correctly

**Action:** Trim the cable tie and rotate it so join is tucked under the footpeg

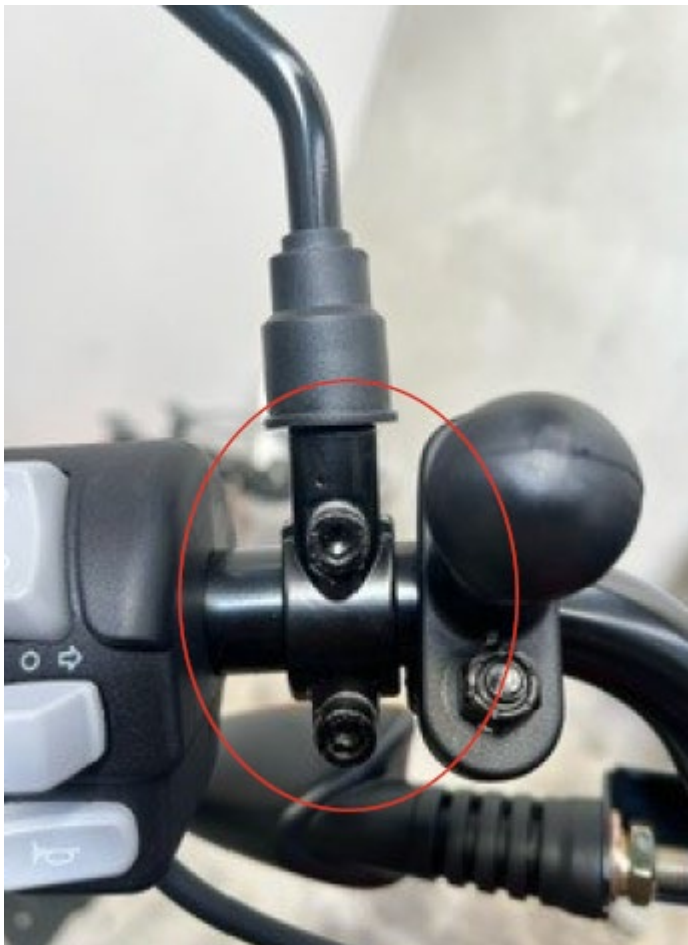
**Title:** Mirror mount saddles to be tensioned up evenly

**Issue:** When installing mirror mount saddles if not tensions up evenly this can damage the saddle.

**Action:** Tension evenly when installing mirror mount saddles 5Nm. New longer bolts will be supplied for fitting the Australia Post letter carrier.

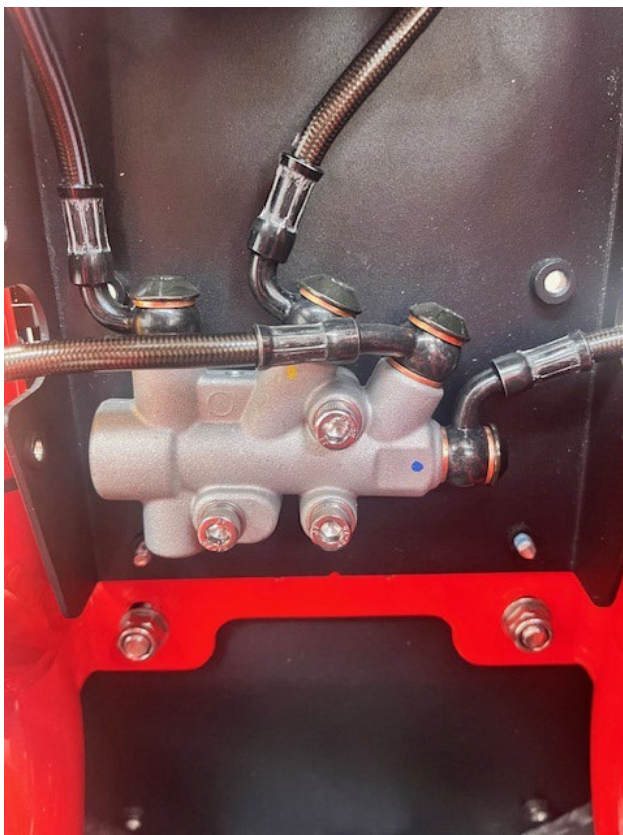
**Title:** Check all brake banjo fittings are firm on the CBS unit behind the front console

**Issue:** x2 banjo fittings were found to be loose during QA check of bikes when landed in AU. This resulted in some of the brake fluid being lost and poor brake handle pressure.

**Action:** Inspect banjo fittings on CBS unit while front console is removed to ensure tight and nil leaks. Tighten as necessary to 25NM. Carry out brake system bleed if necessary to regain handle pressure.

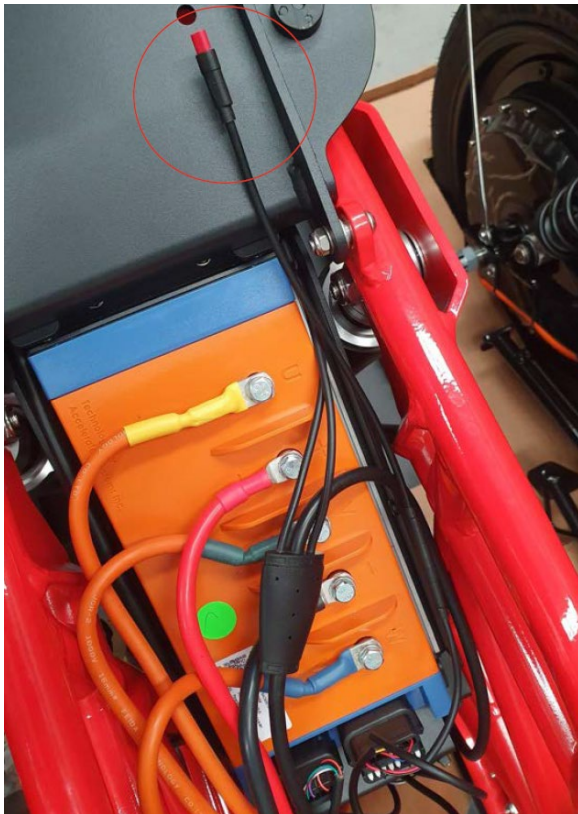
**Title:** EXT. Harness for telematics.

**Issue:** Cable is too short and cannot connect to Telemetric Unit.

**Action:** Extension harness to be fitted.

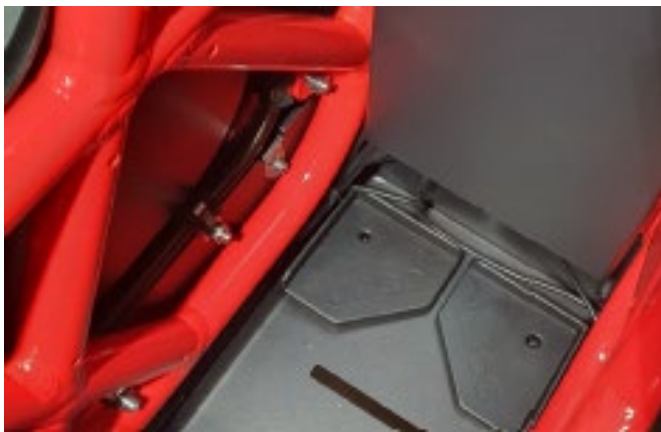
**Title:** Cables crossing over battery pad.

**Issue:** Battery cables are not secured and could get crushed under the battery.

**Action:** Ensure battery pads are fitted. Secure cable using cable ties to ensure clear of battery/pads

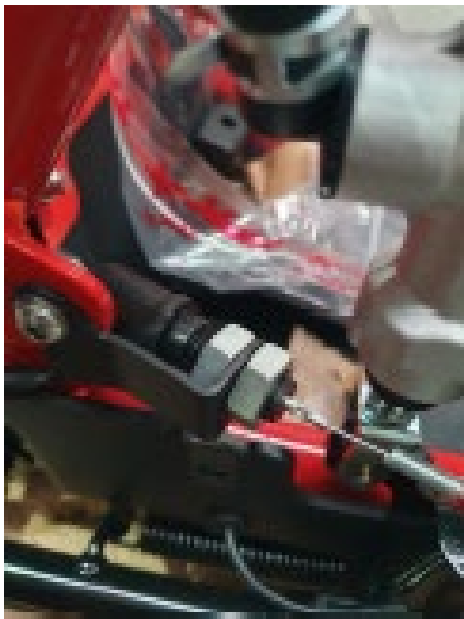
**Title:** Rear Brake Switch Nuts Loose

**Issue:** During an inspection of the sample Rear Brake Switch nuts on some bikes were found to be loose. This could potentially cause them to rattle off and the bike to have no brake switch.

**Action:** Tighten nuts

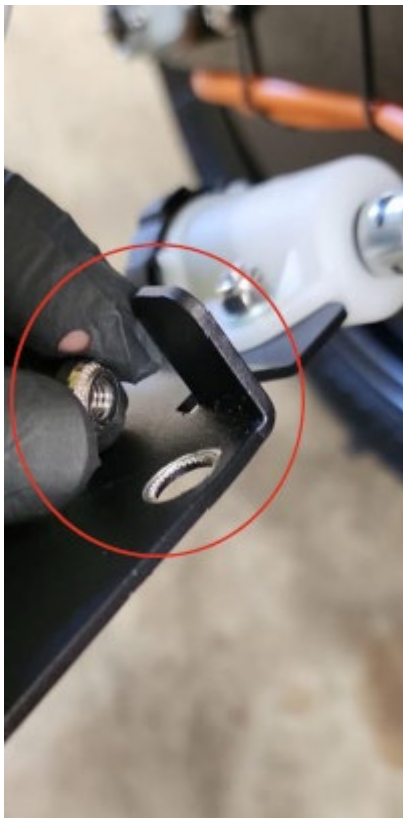
**Title:** Captive nuts loose or missing

**Issue:** During the initial inspection of sample bikes, there were some captive nuts found to be loose or missing.

**Action:** Replace captive nut using Rivet nut as necessary.
